United Medical Maintenance Services

Engineering Publications

T/S ACR Failures on GE CT

This publication is designed to guide you on the proper testing of any CT system prior to ACR testing.

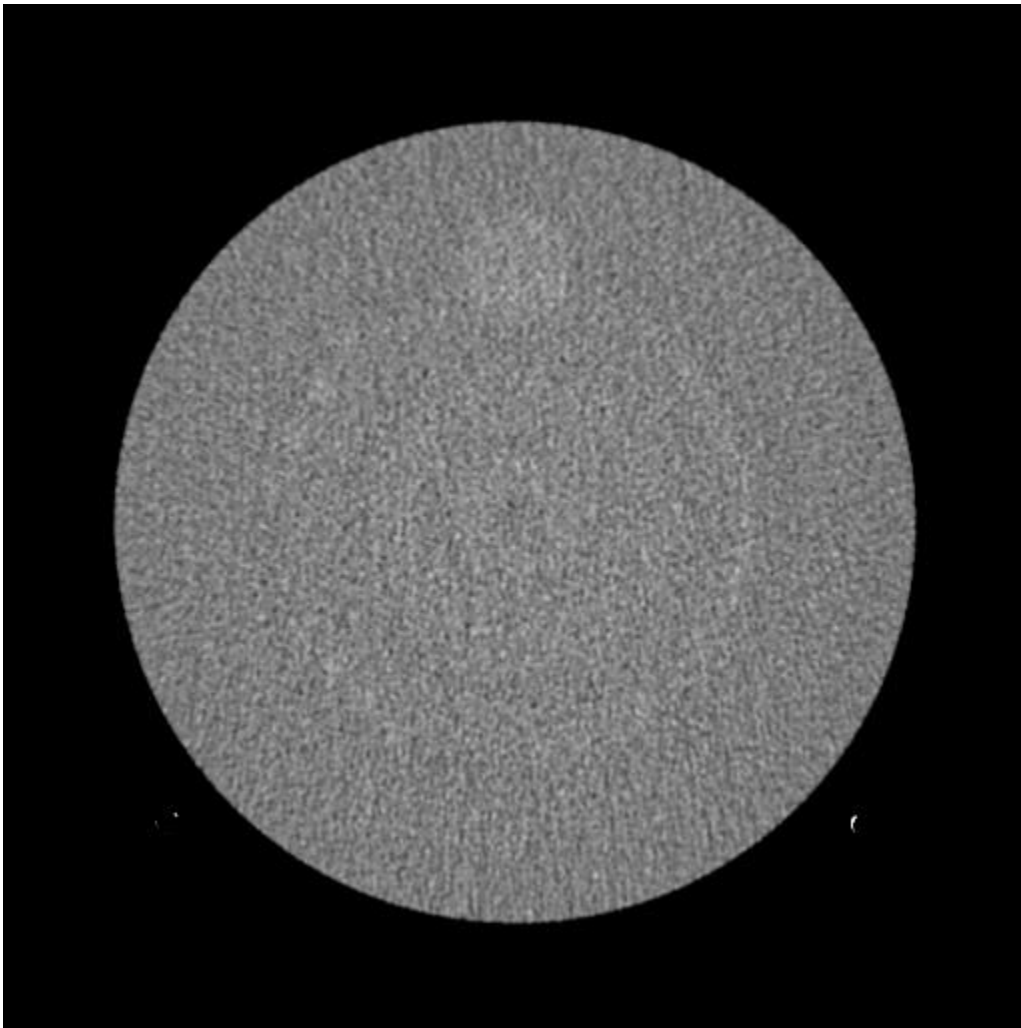
Figure 1

However, in figure one, there is a slight pronounce ring artifact with in the low contrast testing section of the ACR phantom. Tuning and calibration would not remove the ring artifact. ACR will fail any unit that has artifact. In the remaining testing for ACR there was no evidence of rings any where. In the OEM image quality testing there was evidence of ringing in the images. On anatomy studies the radiologist and technologist had no complaints of any artifact issues.

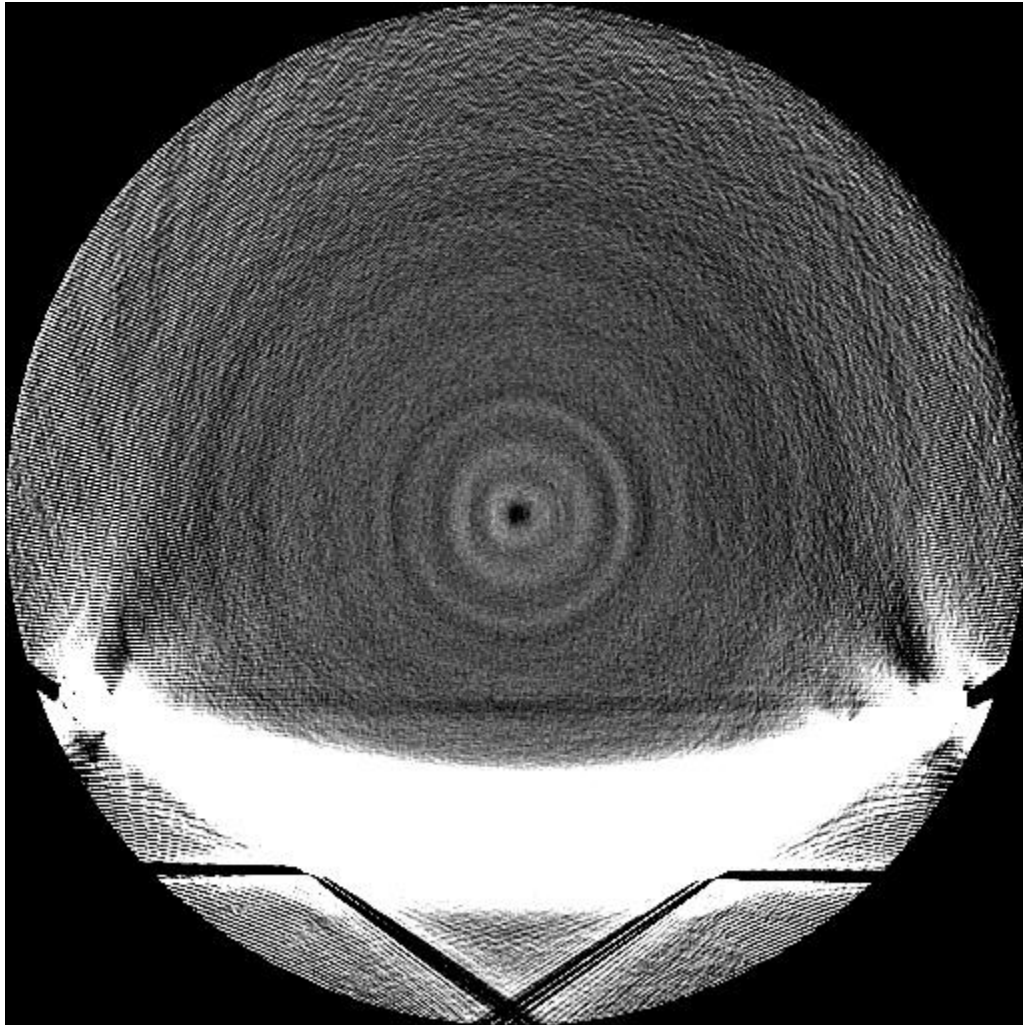
Figure 2

In figure 2, notice the rings in the center of scan field of view. Now refer back to figure 1. Though figure 2 was scanned at 48cm scan field of view, I decided to take this one step further. Ran another test at:

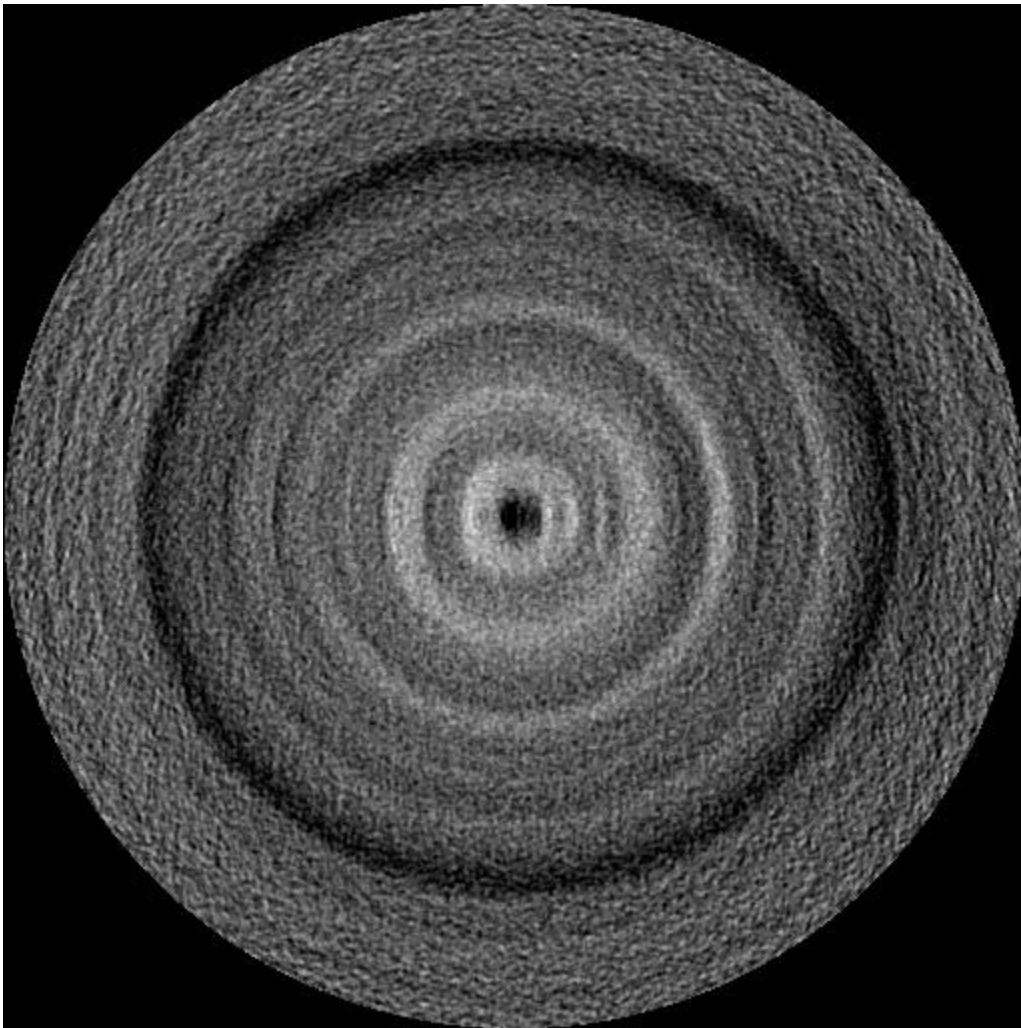
Figure 3

In figure 3, the artifact appears and corresponds to the artifact seen in figure 1. Problem is why only the ACR phantom?

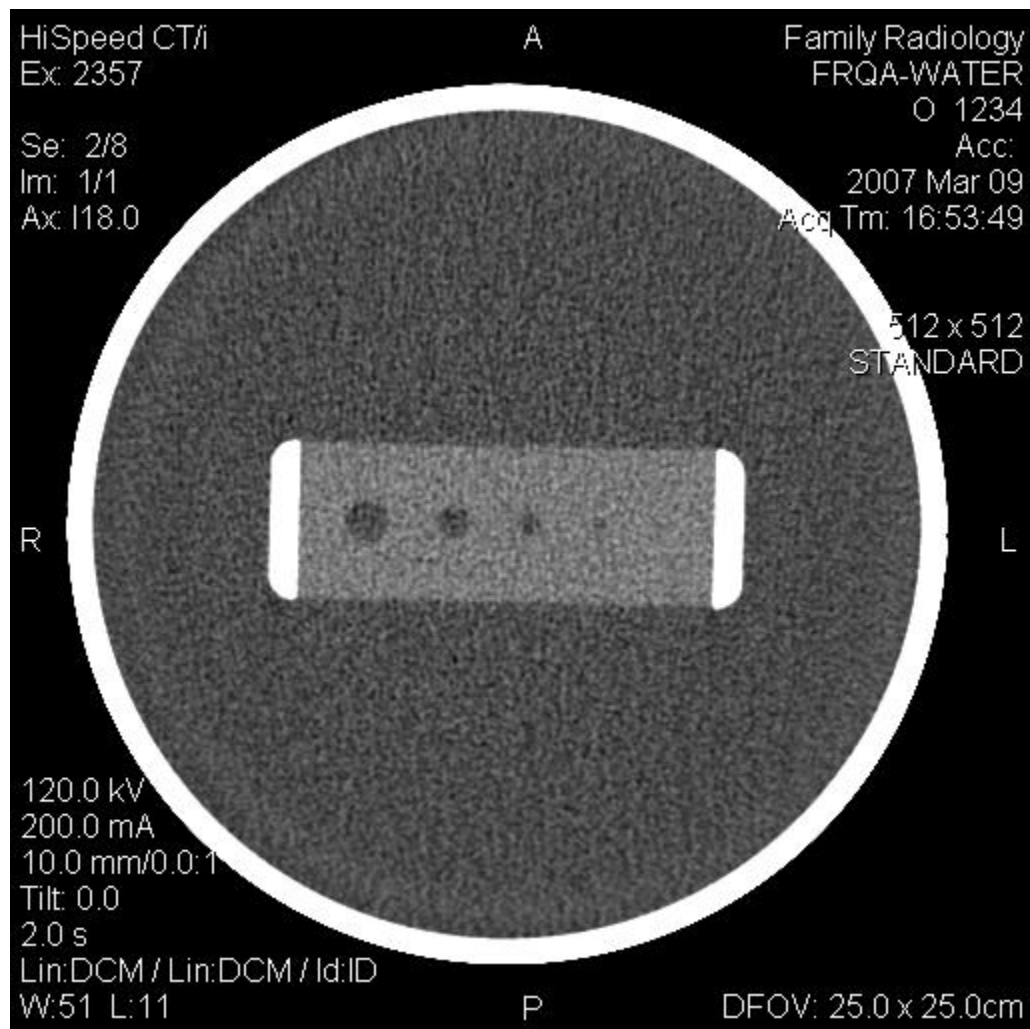
Figure 4

In figure 4, the low contrast testing doesn't show any artifacts. Low contrast passes OEM specifications. Conclusion, the material makeup of the phantom is so light that the attenuation x-rays through this section is extremely close to that of air. The GE phantoms contain water that surrounds all the testing materials.

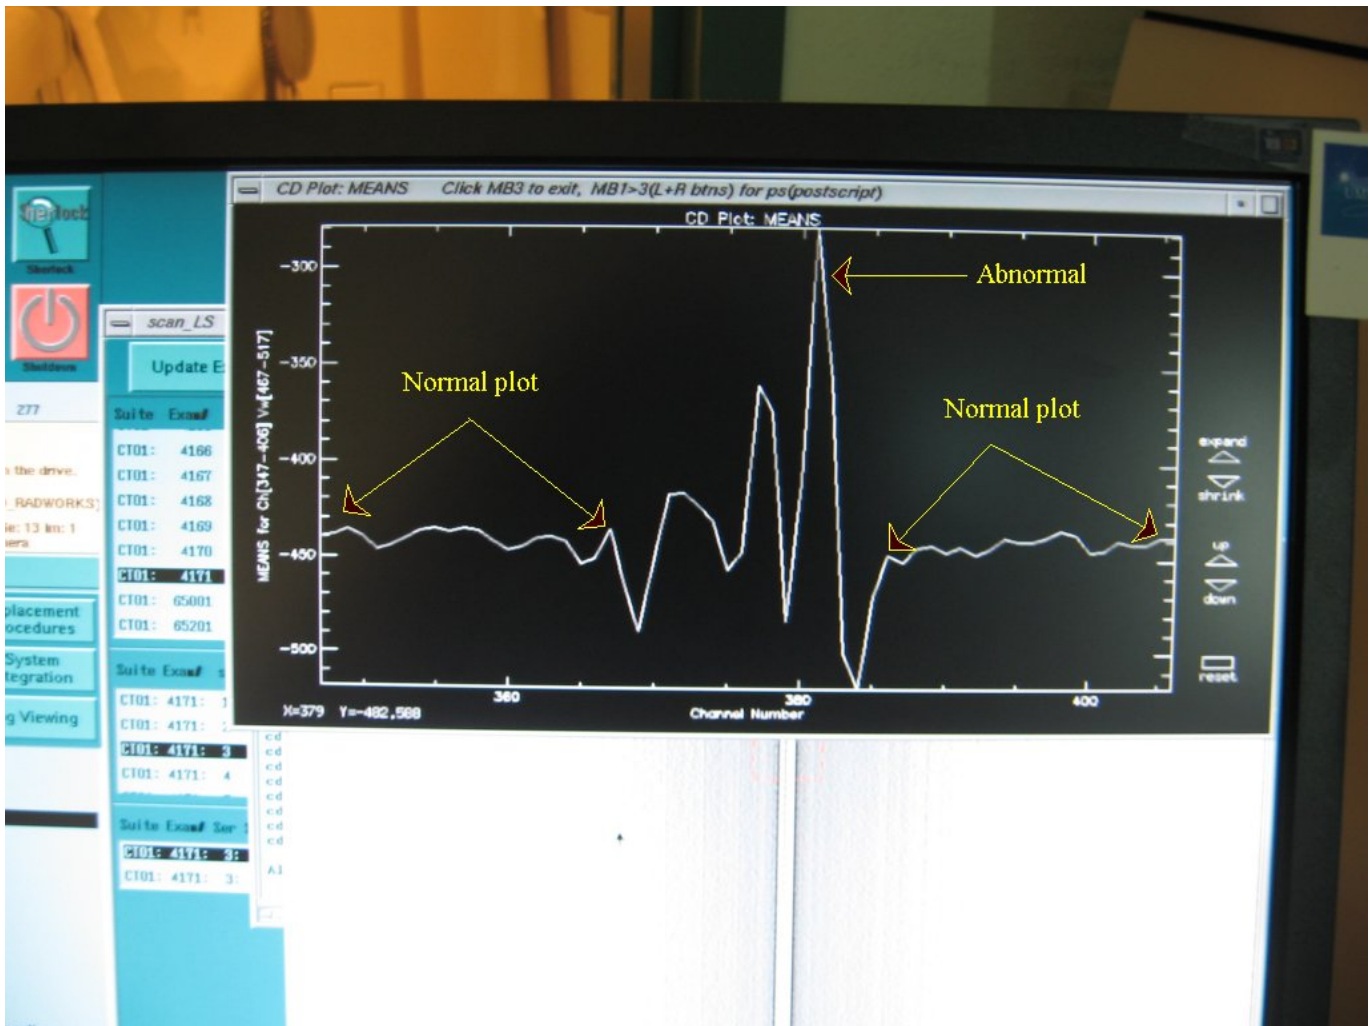
Figure 6

In figure 6, you see a distinct abnormality between detector channels 369 to 384. Next DAS filter card number 23 was replaced. Air and phantom calibrations were run. No change.

Swapped DAS filter cable between DAS filter card number 23 with number 24. Plotted that data and the abnormality move to channels 385 – 400.

Final resolution to the problem was a bad detector array. Replaced the array and the artifact problem cleared up.
