**United Medical Maintenance Services**

**Engineering Publications**

**GE CT Axial Encoder Problem**

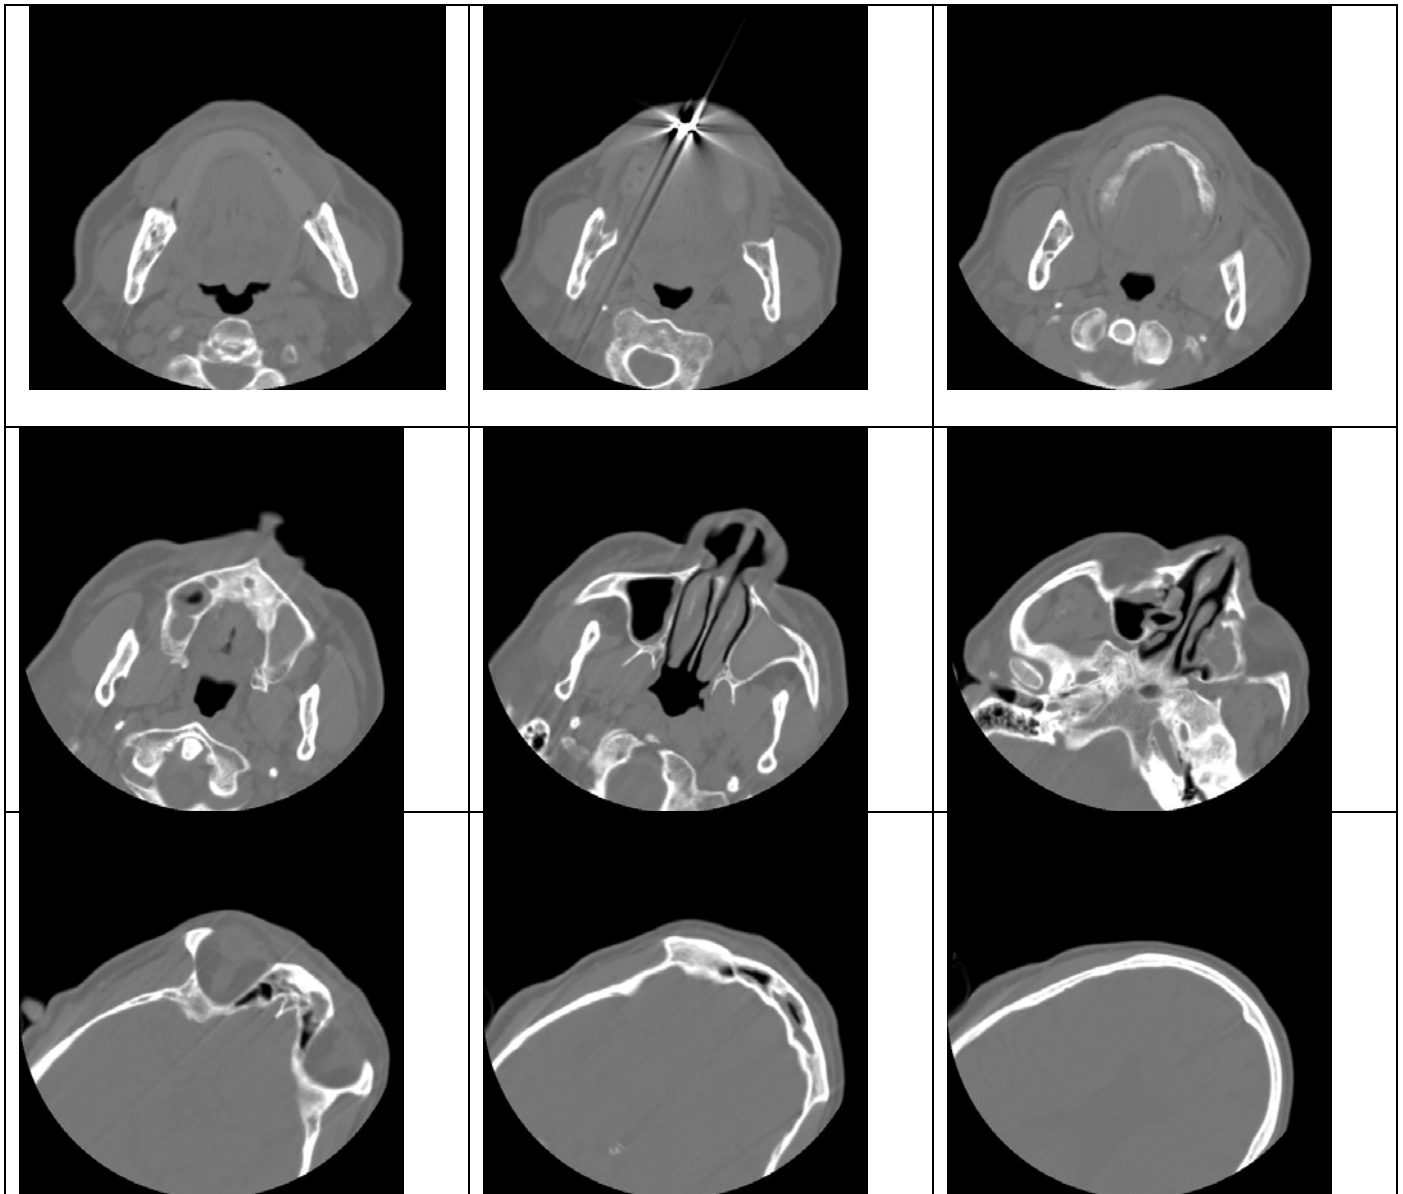
In viewing the images below, the head was tilting but the patient was not actually moving at all.

It was found that the axial encoder shaft was separating from the internal encoder assembly causing a slipping effect as the system rotated. This in part resulted in the images tilting, patient position light off center and eventually causing the rotation system to go offline.
