United Medical Maintenance Services

Engineering Publications

GE MRi artifacts involving SRI

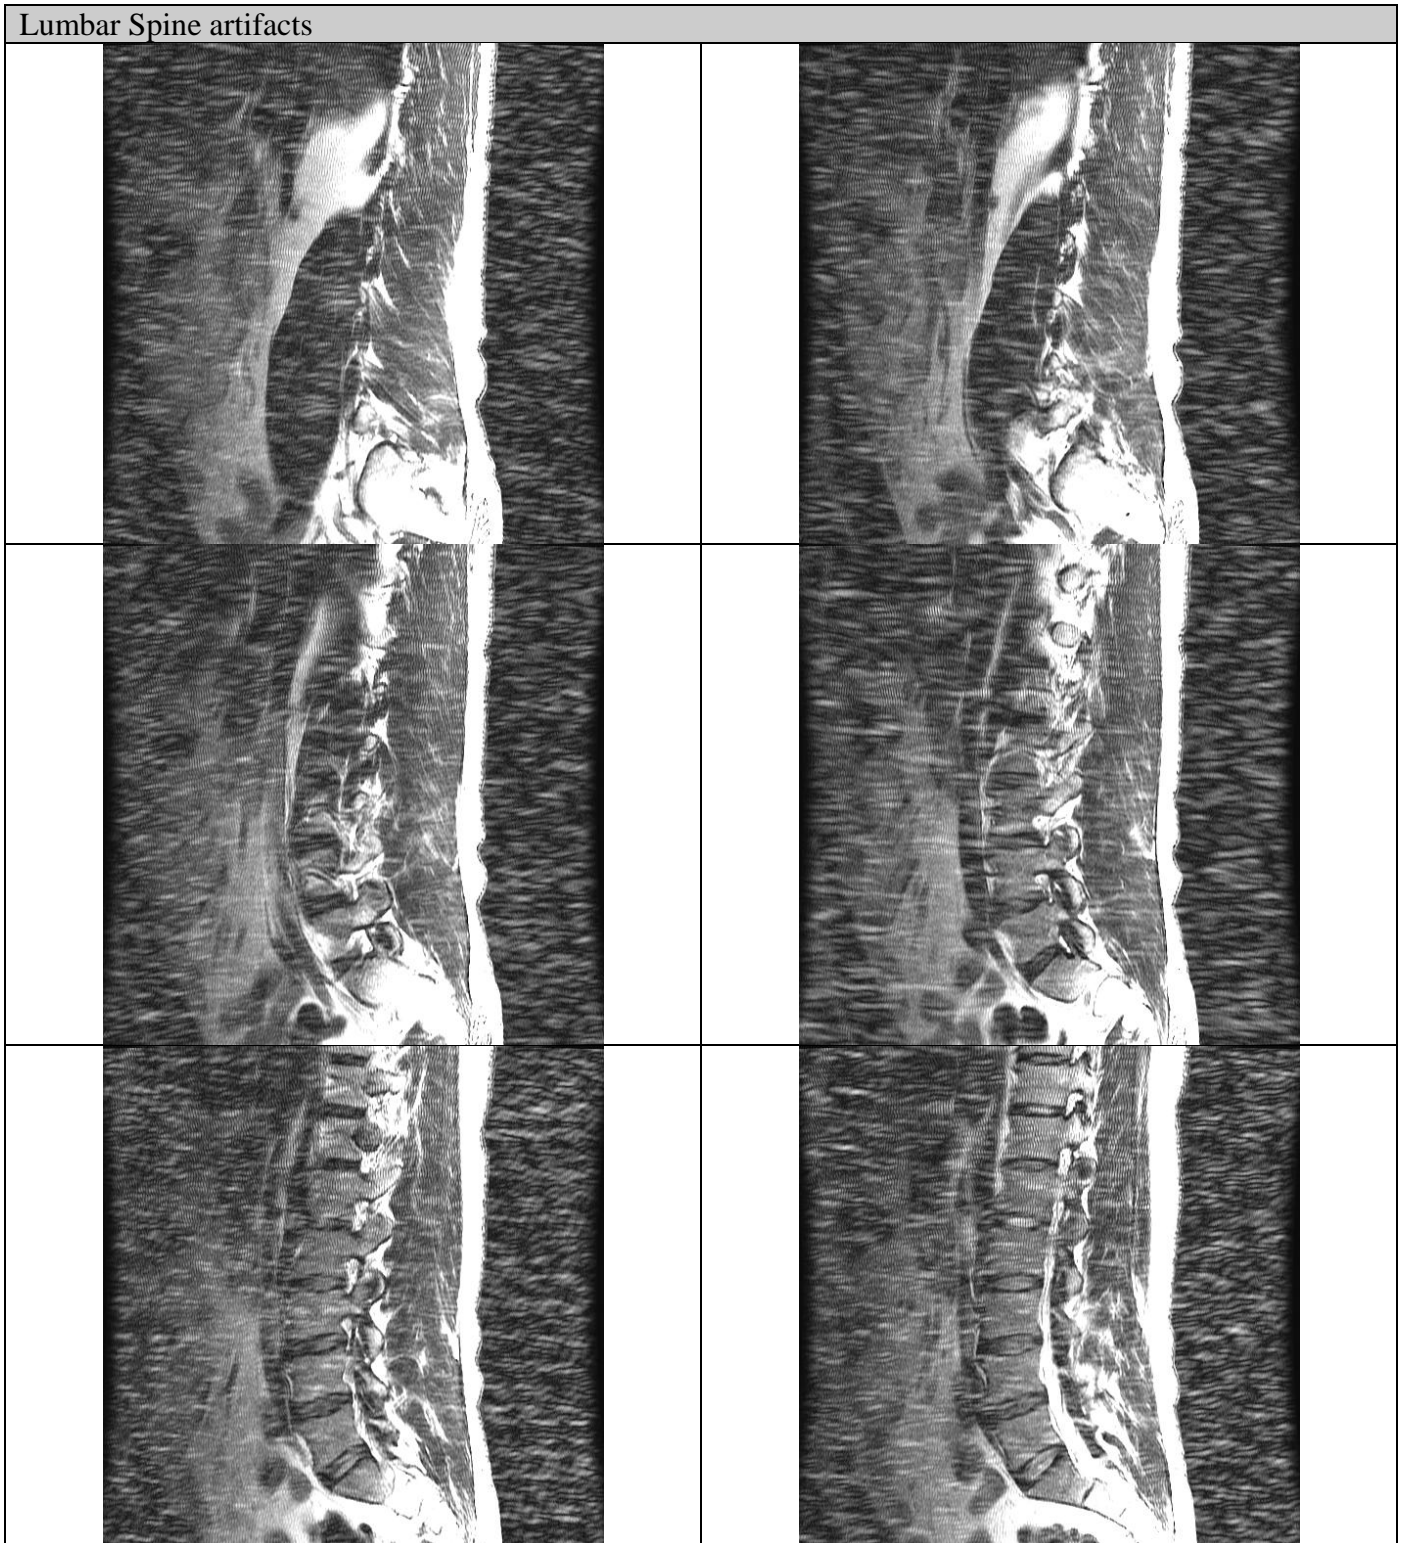
This article involves an artifact that took several attempts of testing and isolating before it was found. See photos below.

- Artifact shows up only on body and all phased array coils using FSE T2, FSE PD, STIR, FLAIR, and Localizer protocols.
- Knees, Extremity and Head coil studies are free of the artifacts.
- SNR for the head, body and phased array pass with no artifacts seen in the image.
- TNS counter logging over 400,000 hits in a one week period.
- SRI display erratic during Body and Phased array studies.

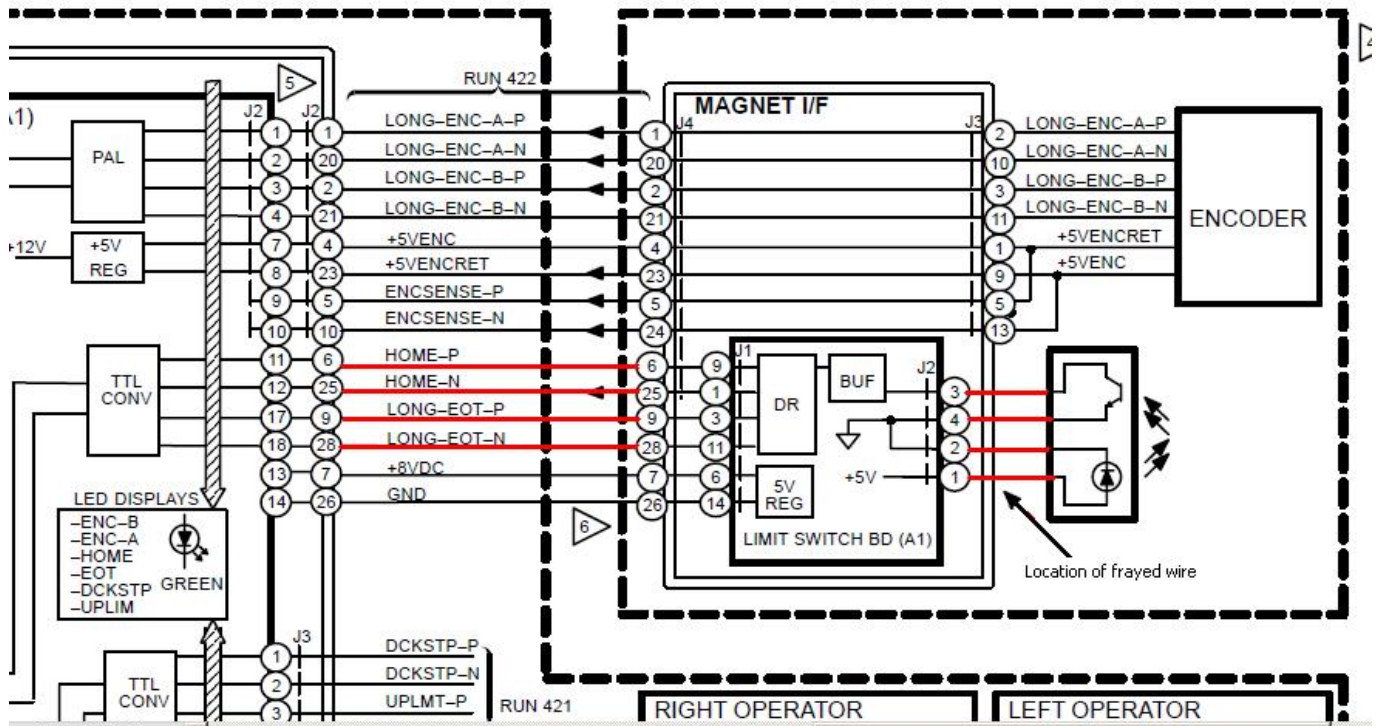
Figure 1

In figure, I discovered that 4 signals are derived from the sensor switch located in the rear pedestal of the table.

- Home – P
- Home - N
- Long-EOT-P
- Long-EOT-N

The **(Home)** signal is simple and self explanatory. It flags the SRI when the table is at the physical Home position clearing SRI table counter to 0. The **(Long-EOT)** or otherwise known as Longitudinal End of Table, tells the SRI that it is at the end of table travel. Since, discovered during T/S, the SRI counter went to a random value. This correlated to the exact distance of table travel to the end of the table. Now given the SRI was replaced and several other components lead us closer to solving the problem. The magnet IF and optical sensor was examined and found a fray wire on the +5 feed to the optical sensor. This with the interaction of the RF power output was the culprit to both the artifacts and the SRI erratic behavior.
