**United Medical Maintenance Services**

**Engineering Publications**

**GE MRI crosstalk artifacts**

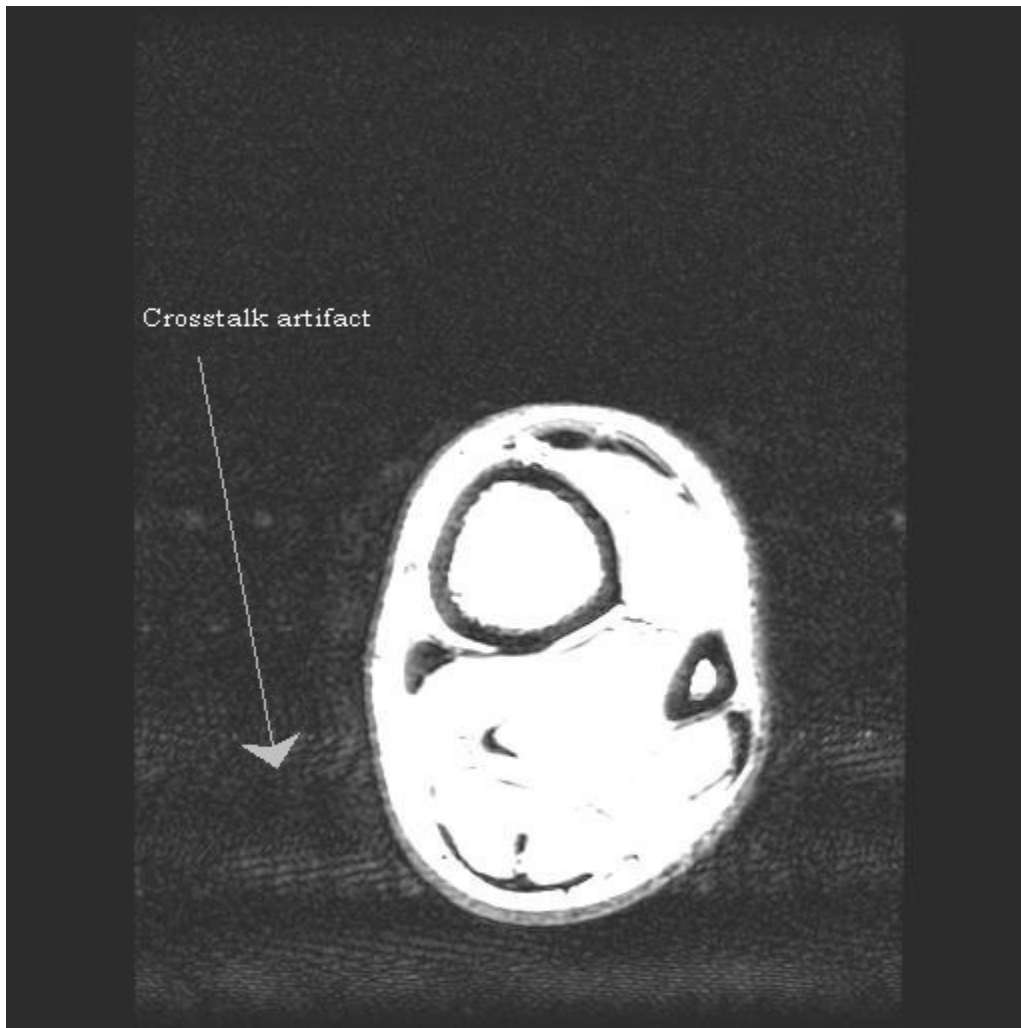
**Figure 1**

Recently I came across a very unusual artifact that was highly intermittent, on high resolution phased array coils, and mainly seen on FSE T2 and some T1 protocols. Refer to figure 1 and 2. Could never reproduce the artifact during service after hours

To no avail all the subsystems checked out. However we did notice the TNS counter taking hits at certain times during the course of normal scanning. As a result the customer would see the artifacts.

The resolution to the problem was that this site had two MRI's, one across from the other in a back-to-back control room. The artifacts were the result of the other MRI unit generating RF noise that was penetrating the others RF shield. It was during our investigation that both MRI's had artifacts. One more pronounced than the other. RF doors were the culprits. Testing of the RF shield revealed weaknesses at the door and pen panel.
